**Sixth Meeting of the Conference of the Parties to the Convention on the
Transboundary Effects of Industrial Accidents**

**DISASTER
IN THE AJKA RED SLUDGE RESERVOIR
on 04 October 2010**

Ltc. Dr. Lajos Káta-Urbán - deputy head of Department for Industrial Safety

National Directorate General for Disaster Management, Mol of Hungary

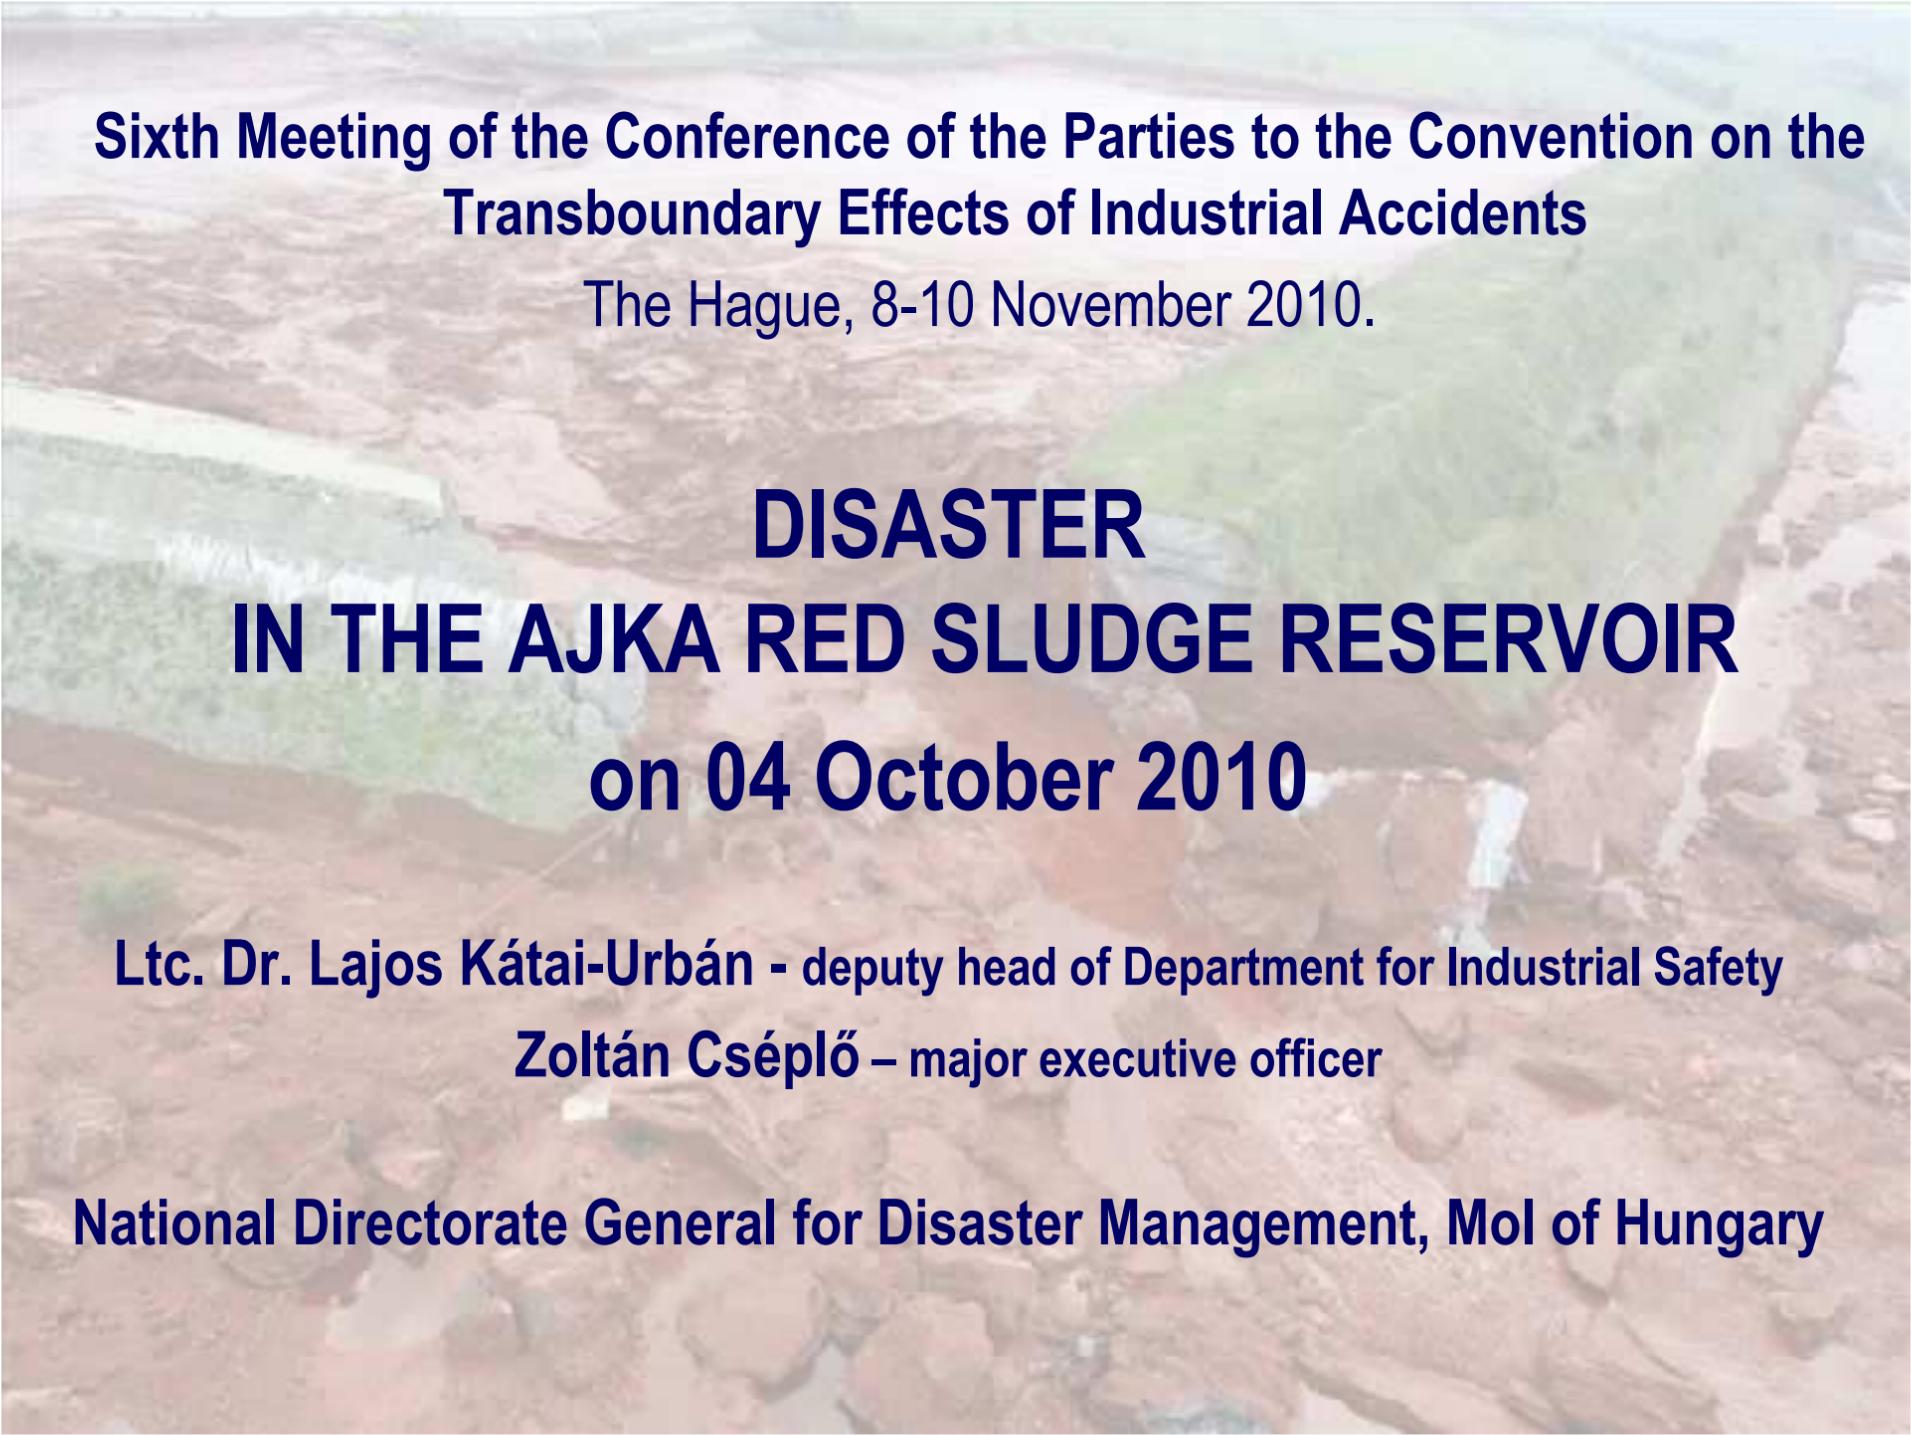
An aerial photograph of the Ajka Red Sludge Reservoir, showing a large, irregularly shaped body of reddish-brown sludge. The sludge is contained within a concrete-lined reservoir, with some green vegetation visible on the surrounding land. The text is overlaid on the image.

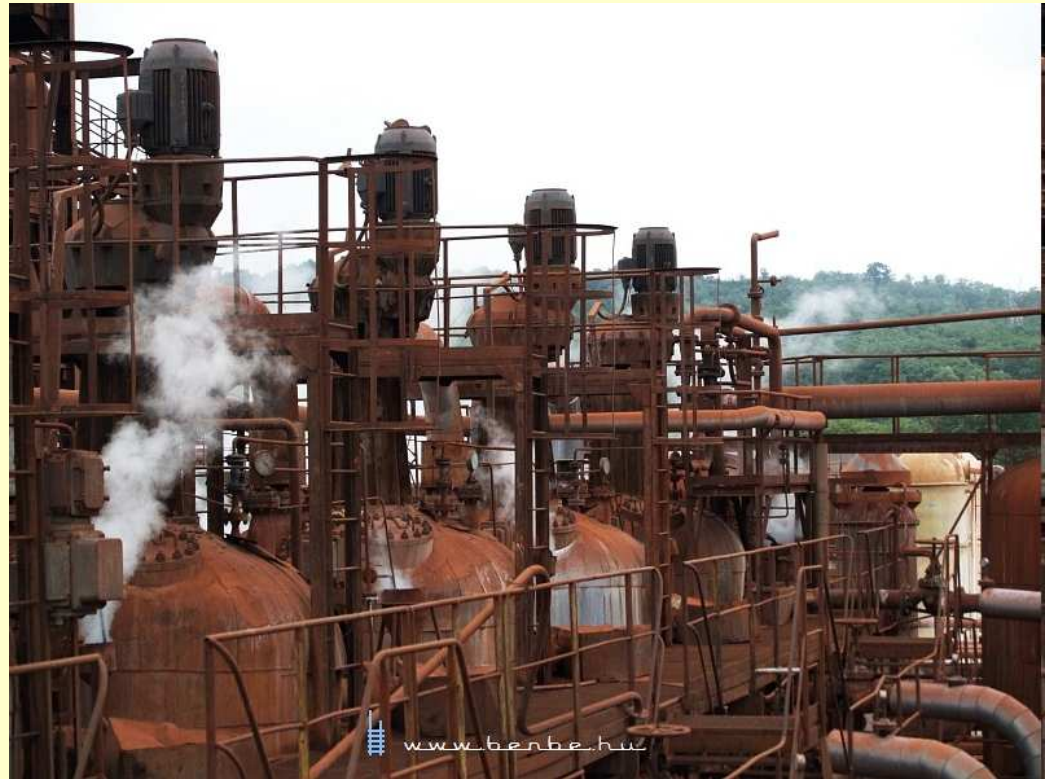
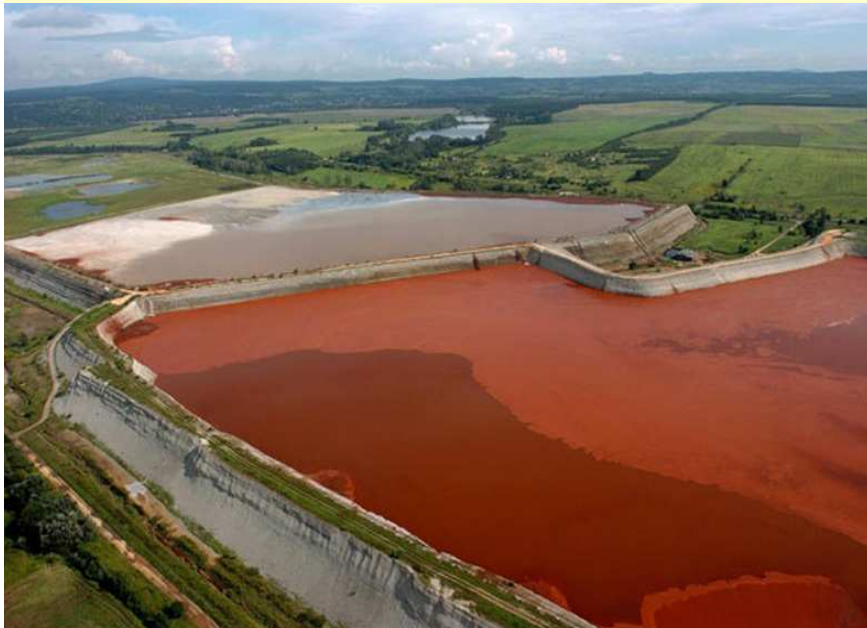
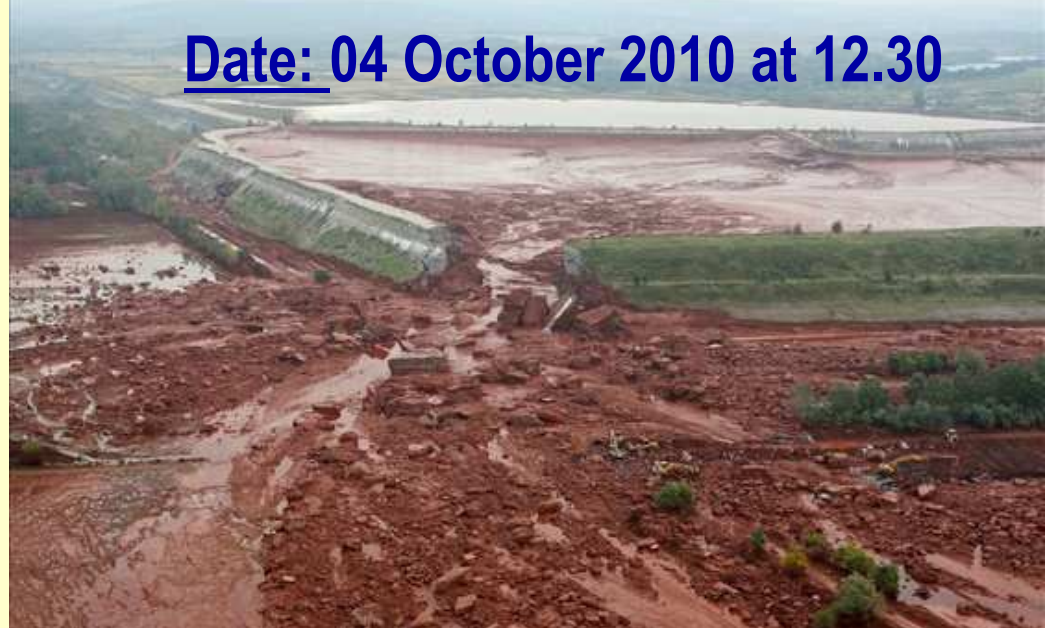
The industrial activity and an event

- Function of plant – red mud reservoir of an alumina plant – MAL Ltd.
- Materials involved in the accident:
- Mixture of red mud (EWC 01 03 09, pH 13) and alkaline water (contained NaOH).
at about 600-700.000 cubic metres

Date: 04 October 2010 at 12.30

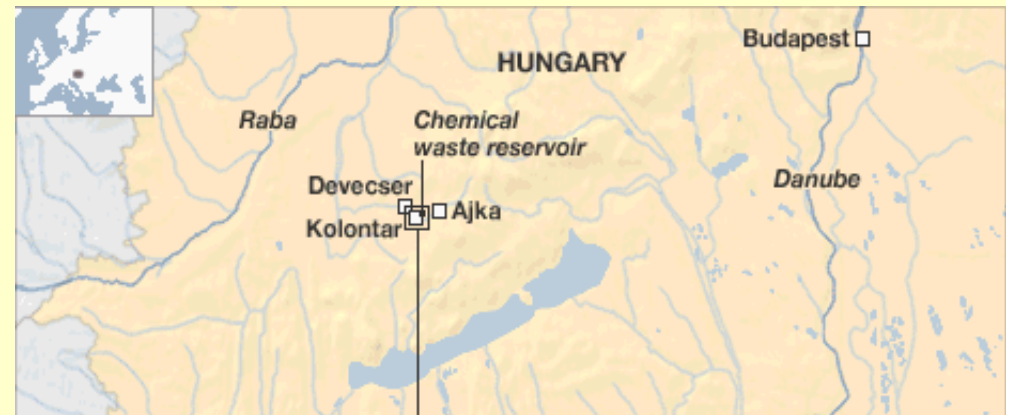
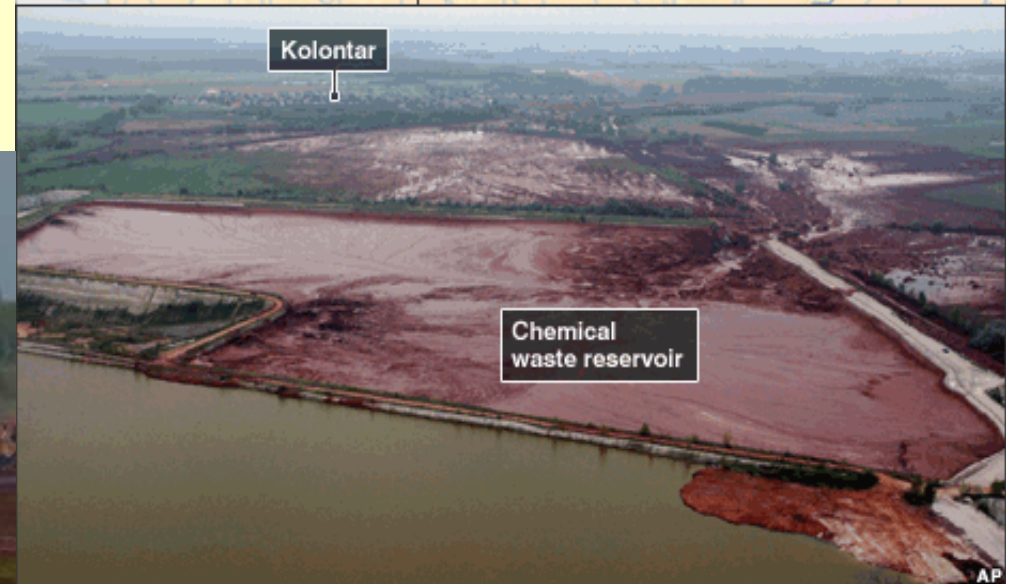
Location of the disaster

Ajka town (Veszprém County) –
distance from the capital
(Budapest) approx.
160 km

Red mud (sludge) reservoir of the
MAL Ltd.

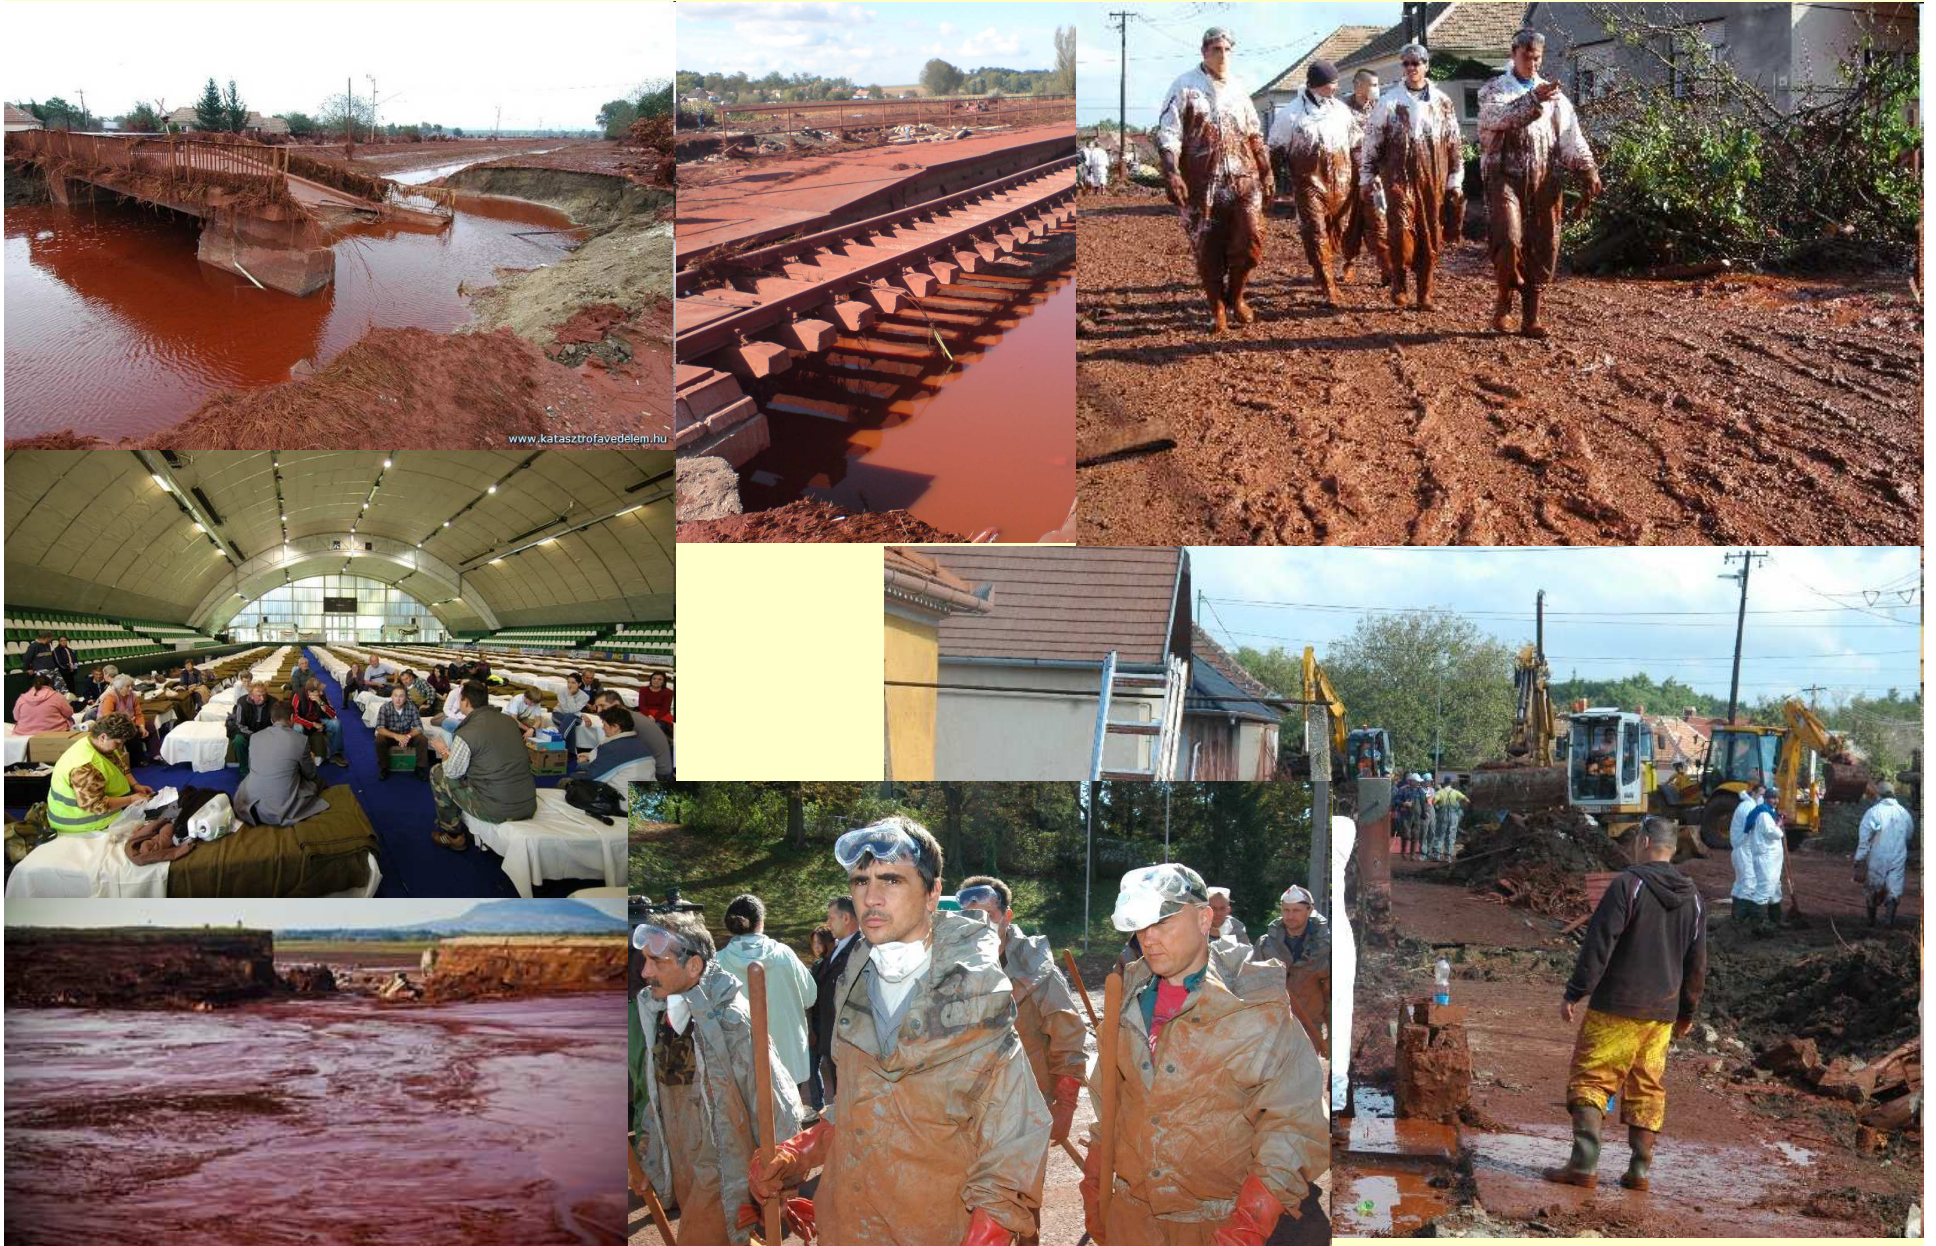
Consequences of the Disaster

17 houses

207 houses

35 houses

1017 ha land
affected

affected persons:
790

10 persons died

123 persons injured

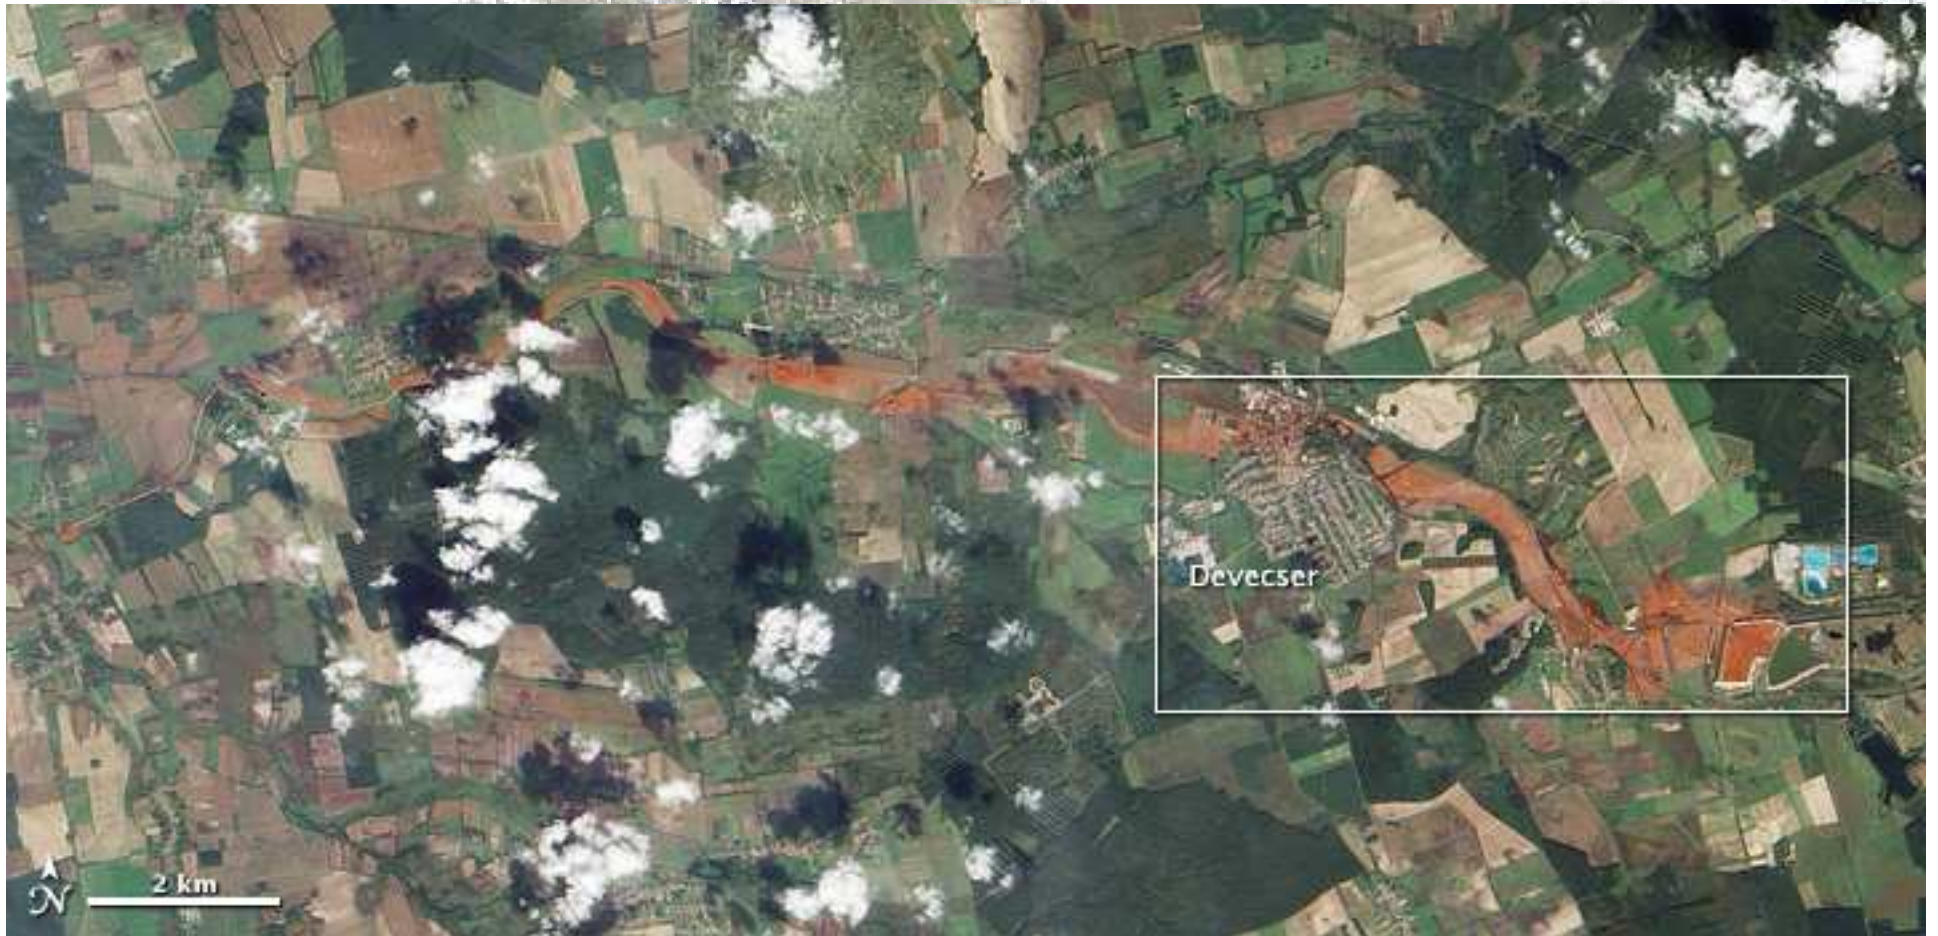
Affected areas

Advanced Land Imager (ALI) system - NASA Earth Observing-1 (EO-1)

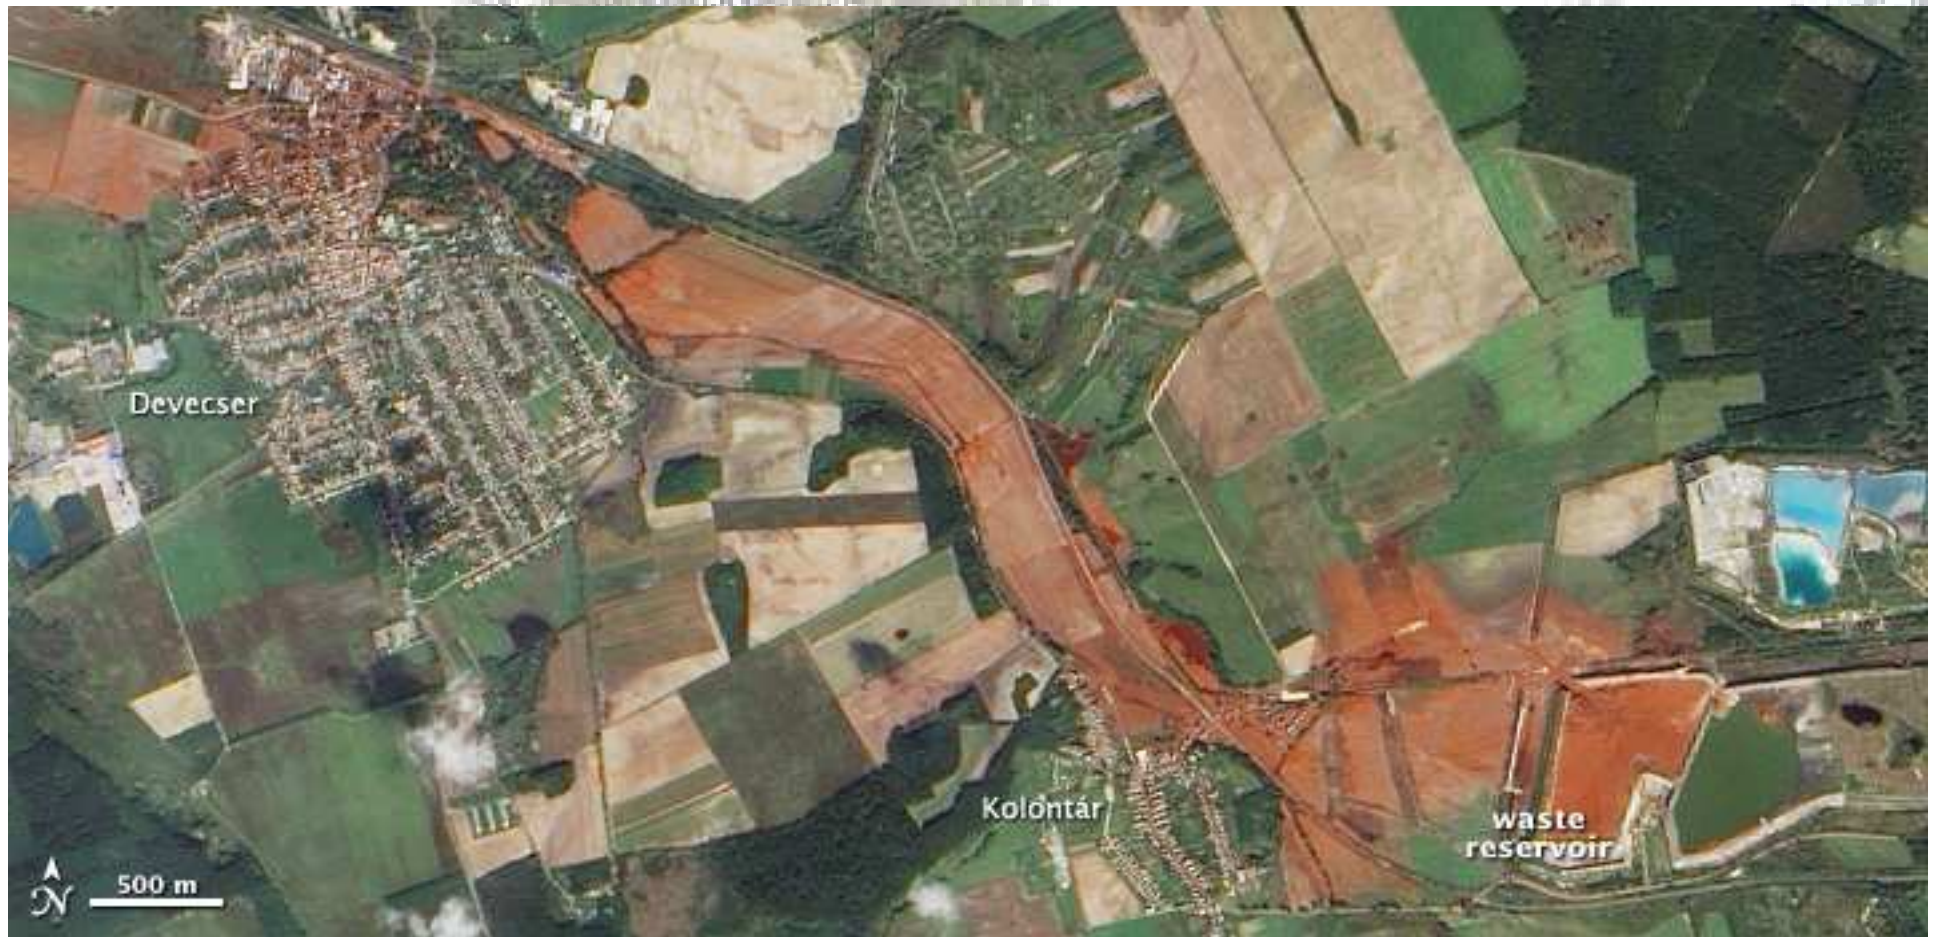
Affected area

Advanced Land Imager (ALI) system - NASA Earth Observing-1 (EO-1)

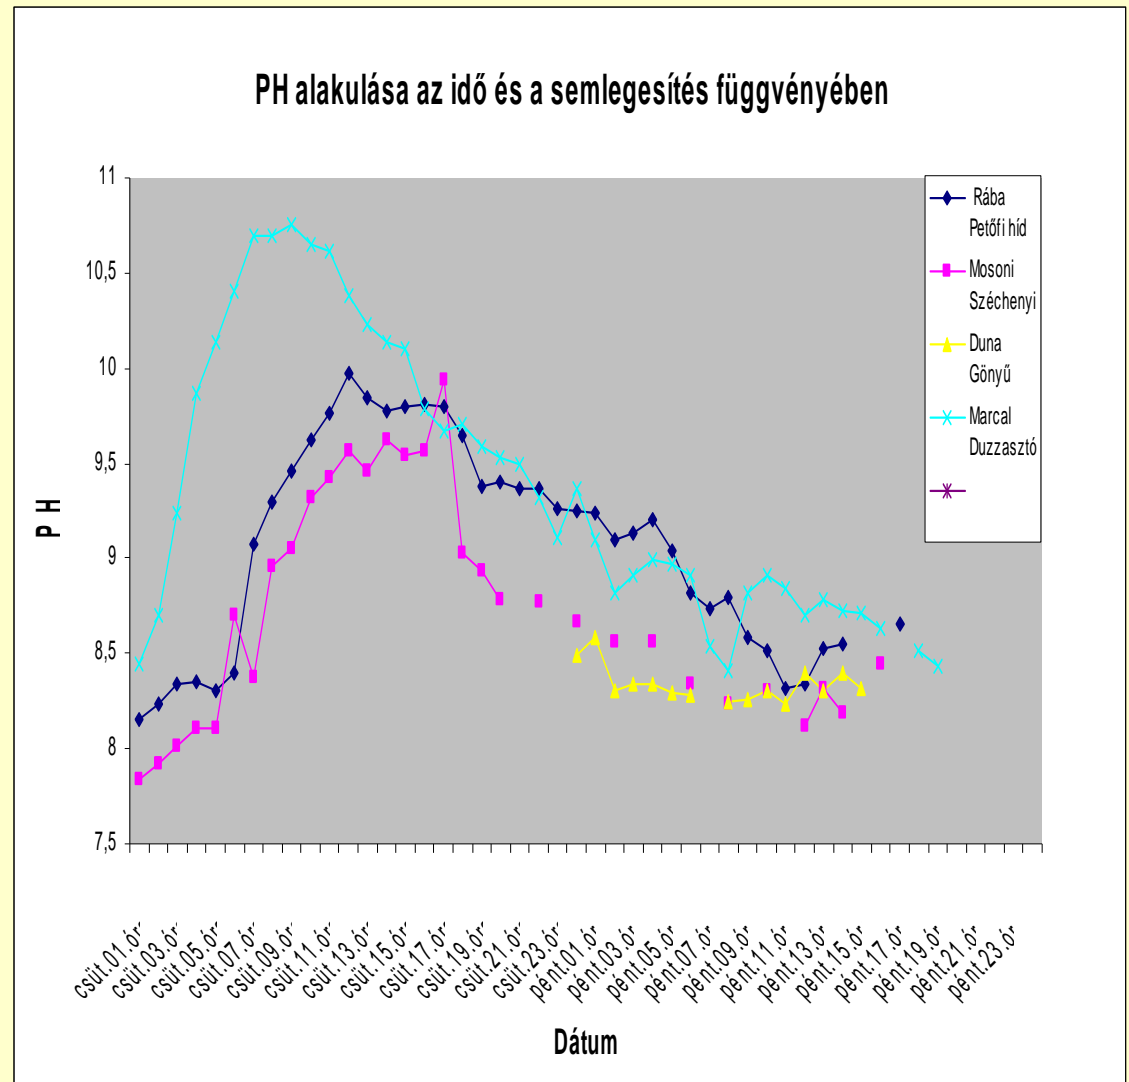
Surface water decontamination 1.

The waste water and red mud has not achieved water level of ground in affected villages.

Decontamination of the affected areas:

Bio-acetous acid: 247337 litres

Gypsum: 18000 t

Torna, Marcal rivers: flora and fauna died out

Rába, Duna rivers: not affected

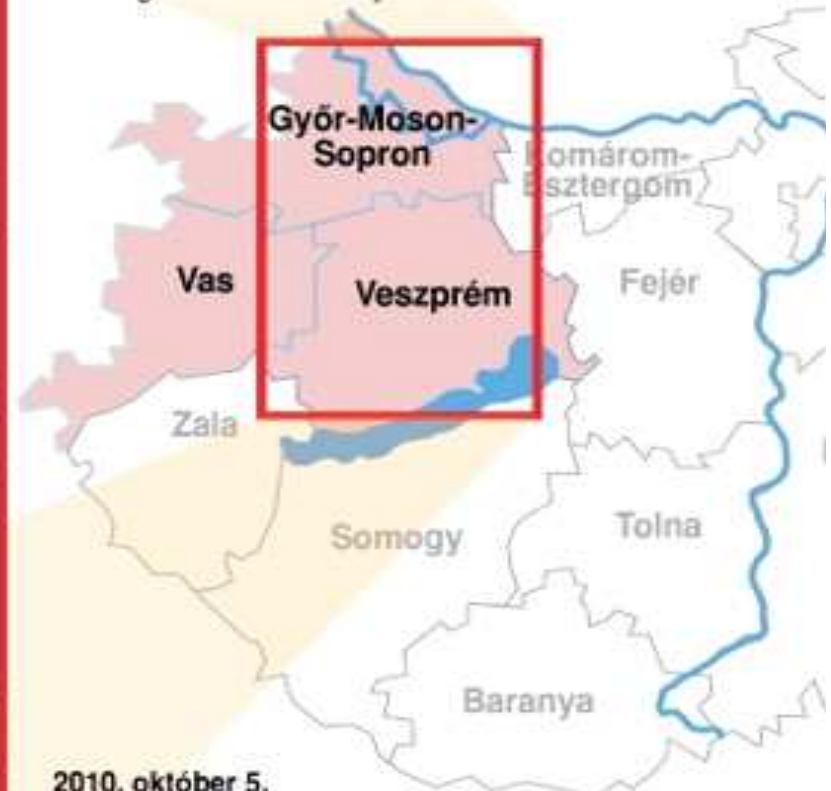
A Magyar Alumínium Termelő és Kereskedelmi Zrt. (MAL Zrt.) Ajka melletti tározójából több százezer köbméternyi mérgező vörösiszap ömlött a szabadba gátszakadás miatt. A térségben katasztrófa helyzet alakult ki.
